**NATIONAL REGISTER TESTING OF  
A RAILROAD EMBANKMENT FOR THE  
HOLLYGROVE DRAINAGE IMPROVEMENTS  
FEATURE, SOUTHEAST LOUISIANA URBAN  
FLOOD CONTROL PROJECT,  
ORLEANS PARISH, LOUISIANA**

Final Report

August 2001

EARTH SEARCH, INC.  
P.O. Box 850319  
New Orleans, LA 70185-0319

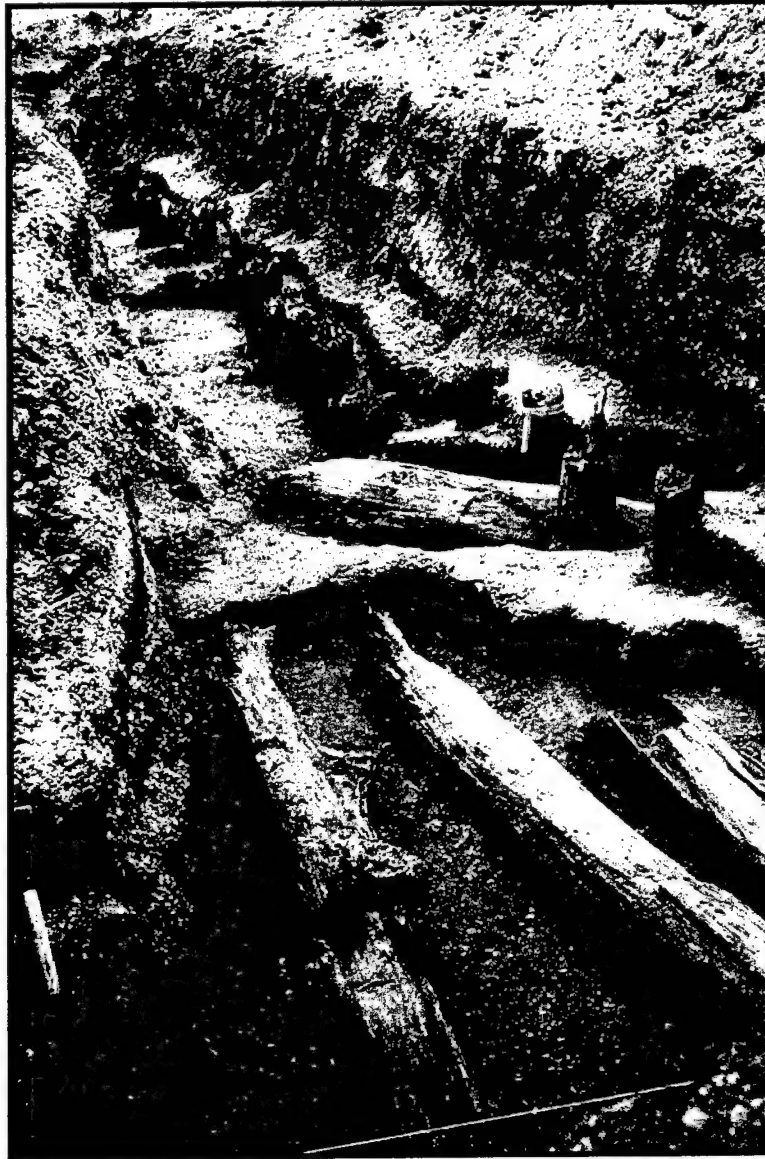
Plate 9. Photograph of cypress and pine structural elements in Trenches 5 and 6.

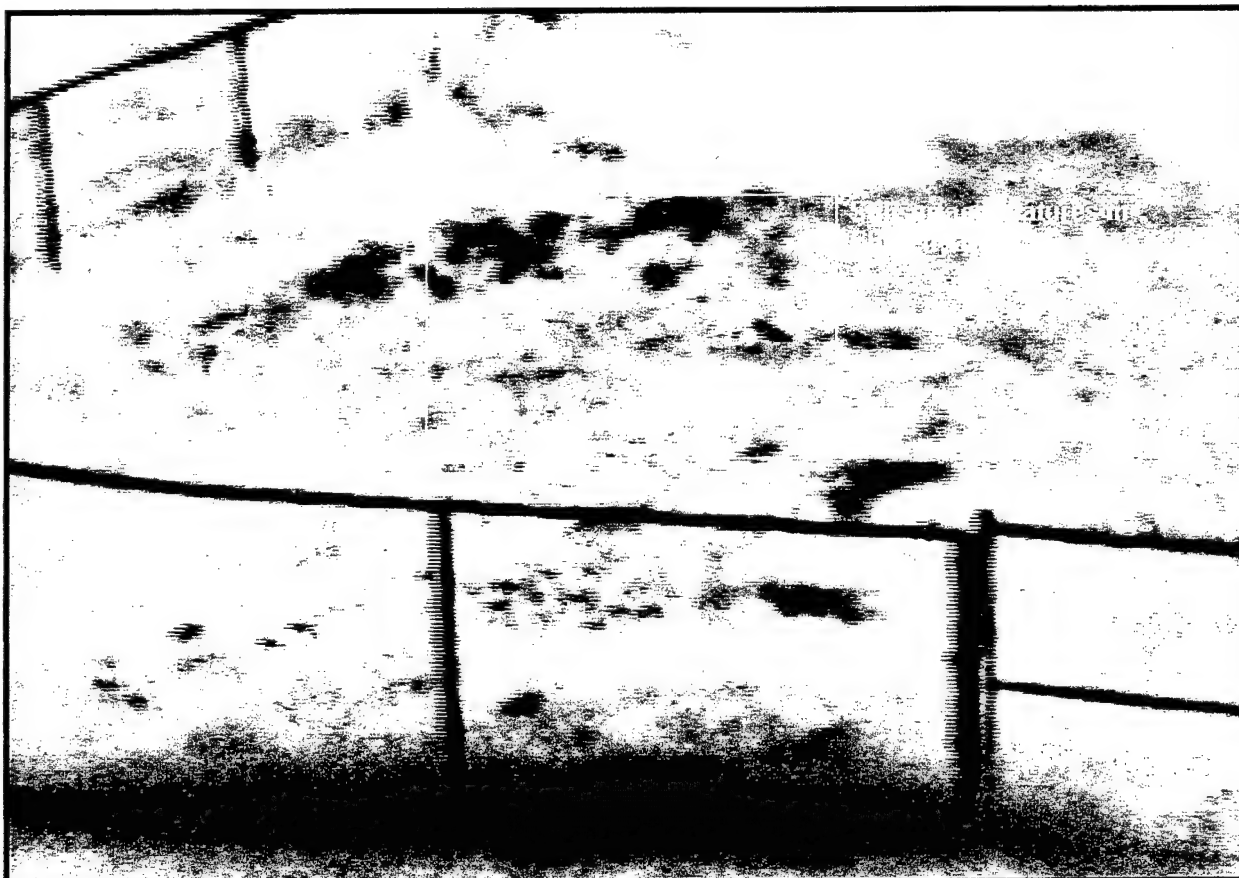
Plate 18. Thermal image of the churchyard at the corner of Hollygrove and Oleander streets showing subsurface features.
